# Manhole Inspection Summary

Manhole # S13S\_\_031MH

**Location** Address: **923 Desoto Rd** Cross Street: **Wilmington Ave**

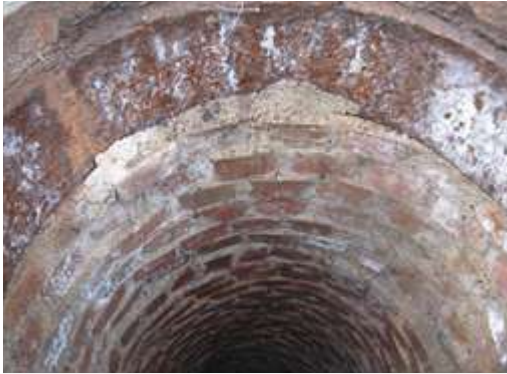
Defect 2

**Frame** Offset: **0** (in.) Condition: ☐ Sound ☐ Cracked ☒ **Leaks**

Frame leaks

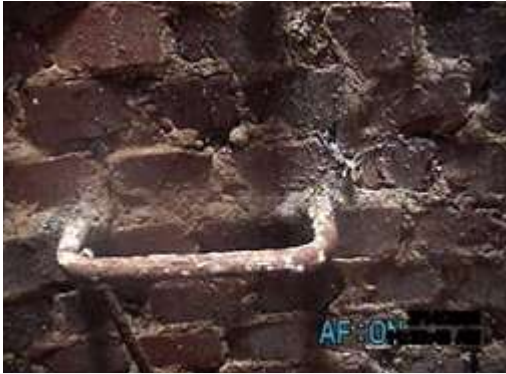
Defect 1

**Steps** Count: **11** Missing: **0** ☒ **Corroded**

corroded steps

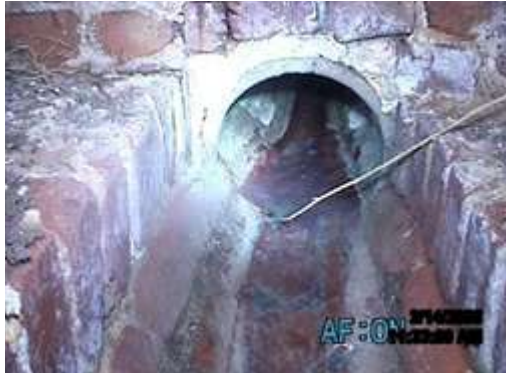
### Defect 3

Condition: ☐ Sound ☐ Cracked ☐ Root Intrusion ☒ **Loose Brick** ☐ Deteriorated

barrel loose bricks

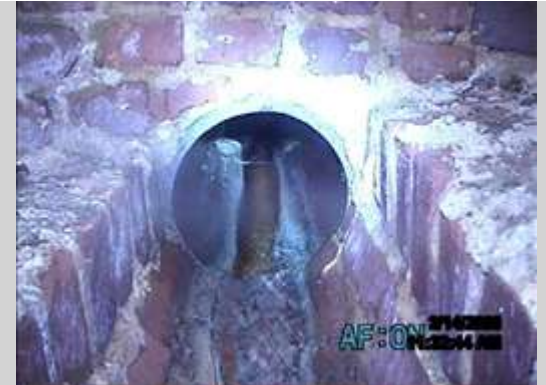
12 O'Clock Outflow

8 in. Circular Gravity Sewer  
Pipe Out @ 12 O'Clock

Pipe Height: **8.4** (in.) Rod and Bar (Angled)  
Pipe Material: **Clay** ☐ Pipe Lined  
Invert Depth: **12.90** (ft.) Flow Characteristics: **Slow**  
Deposits: ☒ None ☐ Mud ☐ Sludge ☐ Debris ☐ Grease  
Silt Depth: **0** (in.) Deposits Extent:  
Infiltration: **None** Pipe Seal Cond: **Sound**

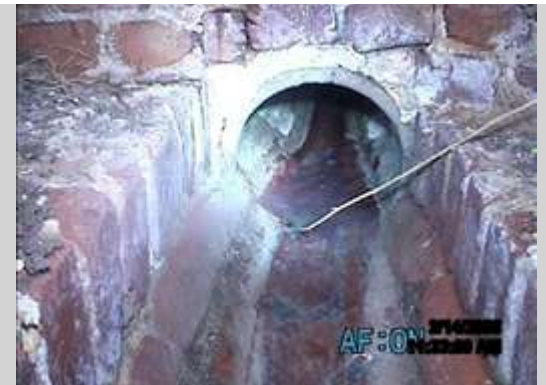
6 O'Clock Inflow

8 in. Circular Gravity Sewer  
Pipe In @ 6 O'Clock

Pipe Height: **8.4** (in.) Rod and Bar (Angled)  
Pipe Material: **Clay** ☐ Pipe Lined  
Invert Depth: **13.10** (ft.) Flow Characteristics: **Slow**  
Deposits: ☒ None ☐ Mud ☐ Sludge ☐ Debris ☐ Grease  
Silt Depth: **0** (in.) Deposits Extent:  
Infiltration: **None** Pipe Seal Cond: **Sound**
